ELECTRONIC FAILURE ANALYSIS

COPPER DISSOLUTION

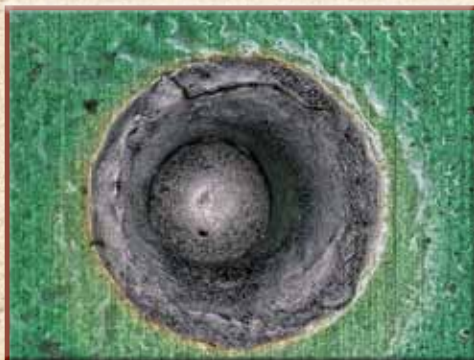
Figure 1: Appears to be a cracked solder joint

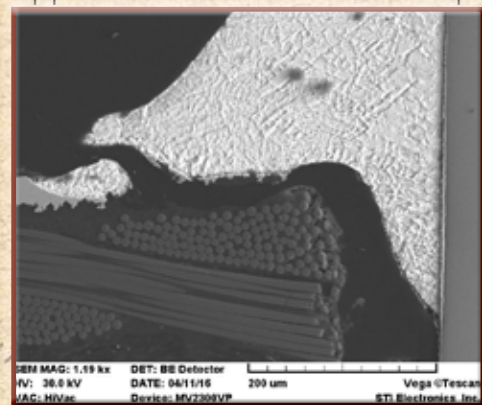
Figure 2: Excessive copper dissolution visible

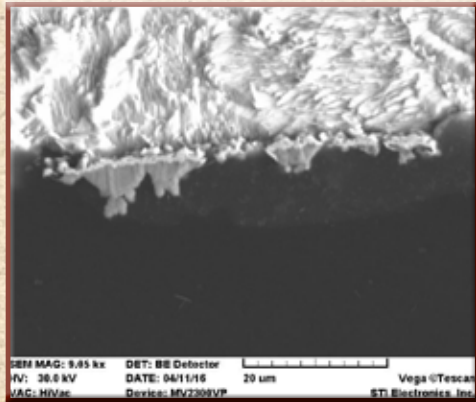
Figure 3: No significant copper layer visible

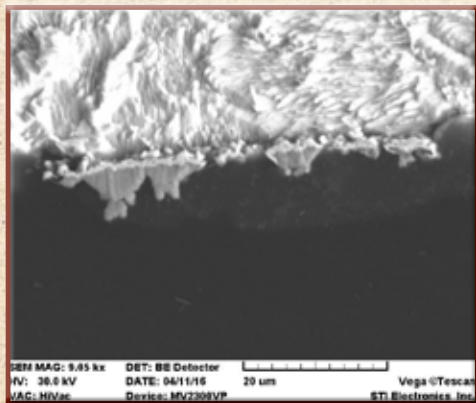
Figure 6: No bulk copper pad present

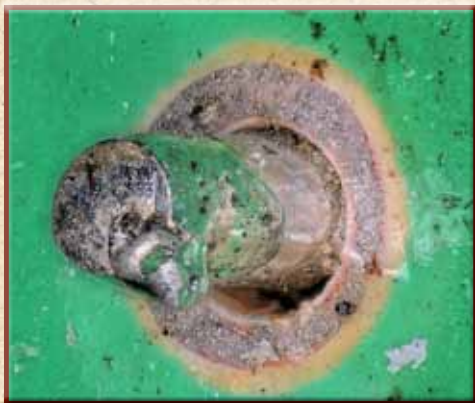
Visual defects can and are sometimes dewetted in appearances. They can also manifest itself as a lifted pad state where the underlying copper pad adhesive system fails.

Figure 7: Dewetting in appearance

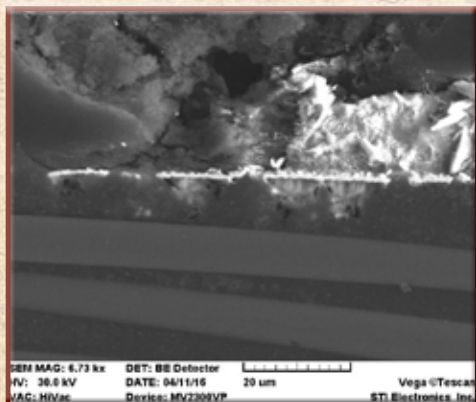
Figure 9: Cross-sectional view of almost completely consumed copper layer at the PCB interface. All one can see is an intermetallic formation with no underlying copper pad support.
